Analysis of microplastic particles in Danish drinking water

Scientific Report from DCE – Danish Centre for Environment and Energy

No. 291

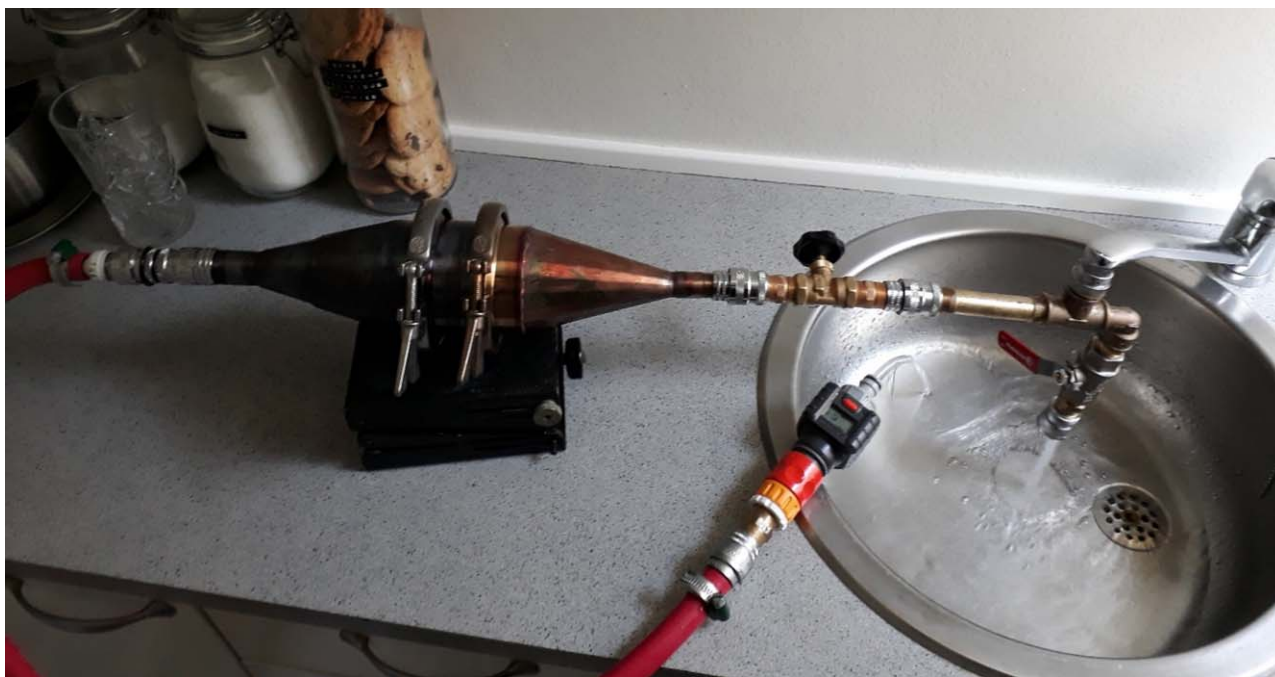
Figure 2. Tap water sampling. Deployment of the stainless steel sampling column to the drinking water tap for collection of 50 L water samples.

Sampling of tap water was performed by direct coupling of a stainless steel column mounted with a stainless steel filter to the tap (Fig. 2), as previously described in the method developed for analysis of MP in tap water (Strand, 2018). A small modification was made to the equipment by exchange of the 20 μm filters with new steel filter nets with a finer pore size and an absolute filtering ability of 11-12 μm .

Before sampling was initiated, a short flushing of the tap outlet was performed for about 2 minutes. The sampling equipment was deployed to the tap using a small pipe with an appropriate thread, which was coupled directly to the sampling column with a fitting. During sampling, the taps were opened to full water pressure, and the flow through the sampling column was adjusted to 2.0 L per minute, while the residual water was led directly to the sink through an outlet tube. For each sample, a volume of 50 L was passed through the sampling column and potential MP in the water were retained in the steel filter for quantification and chemical analysis.
